EFFECTS OF THE TSUNAMI IN THE CHAGOS ARCHIPELAGO

CHARLES R. C. SHEPPARD¹

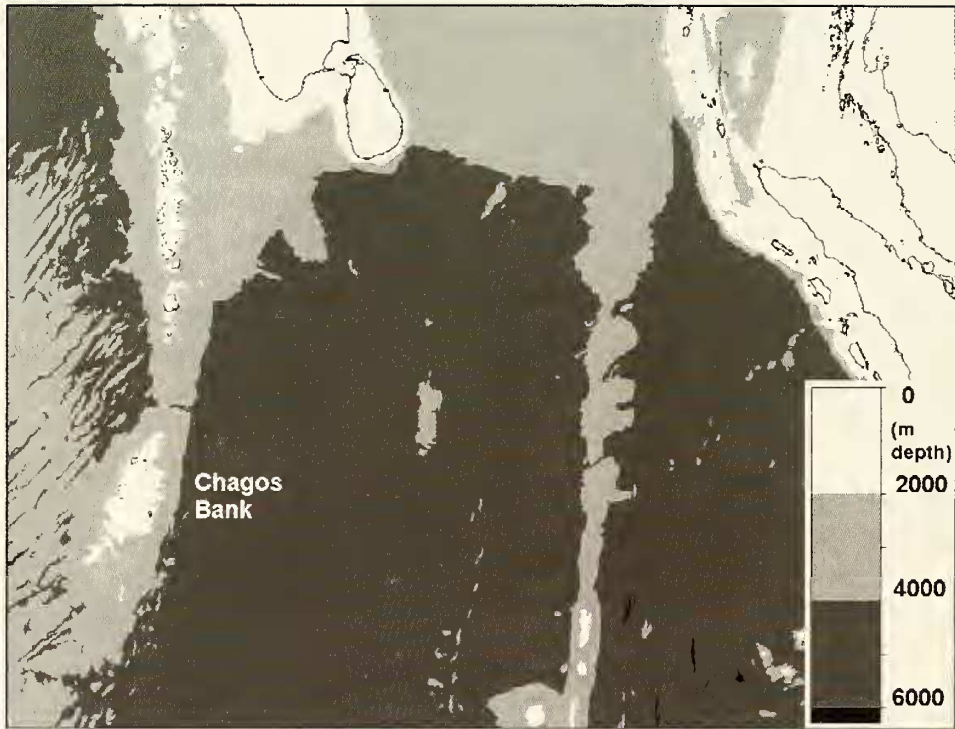
Figure 2. Bathymetry of the Indian Ocean between Chagos and the tsunami site of origin. Taken from GEBCO Digital Atlas (2003). Depth spans are 2000 m depth.

Of particular relevance in the present context is the bathymetry of the region. Unlike the Maldives immediately to the north, most of whose atolls lie in a 'double chain' in relatively shallow water, all atolls, submerged atolls and banks in Chagos are separated from others by deep water, mostly 1-2 km deep (see the inset in Figure 1 which shows the 1000 m contours in Chagos). Deep water lies between Chagos and Sumatra (Fig. 2).

features of the eastern Indian Ocean when that region's bathymetry is examined on a broader scale (GEBCO Digital Atlas, 2000, and see Figure 2). Whether depth effects below 2 000 or 3 000 m are important in connection with tsunami energy is not known to this author.

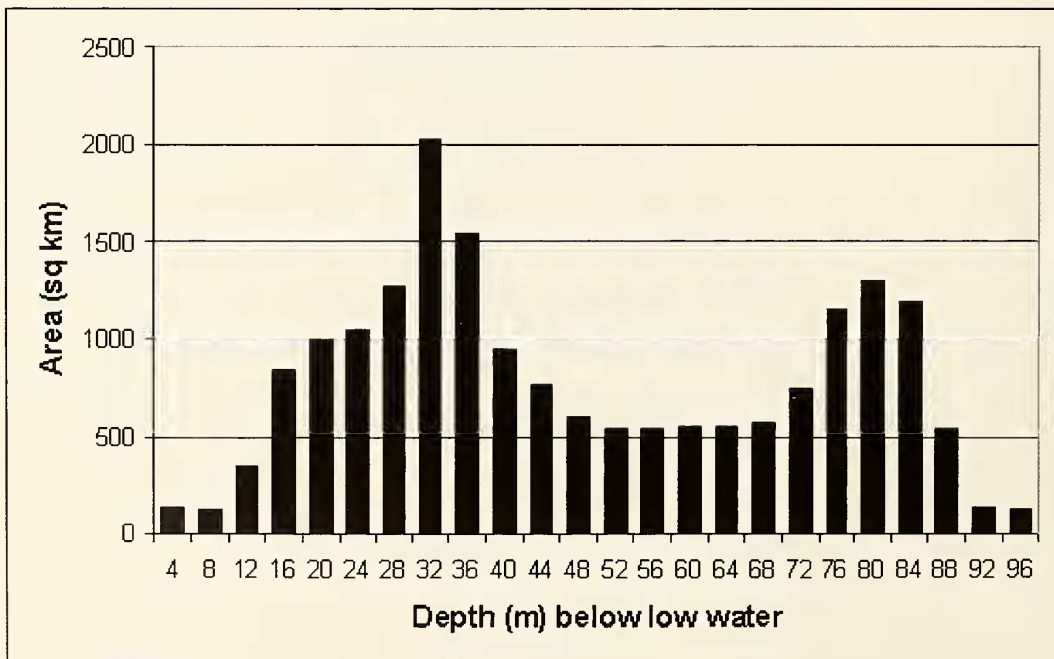
Figure 3. Distribution of areas of different depth spans in the Chagos Archipelago (to 100 m only). On x-axis, each bar indicates the span *to* that depth *from* the shallower depth to its left. From Dumbraveanu and Sheppard (1999).

Within the archipelago, the proportion of substrate of different depths has been accurately computed (Dumbraveanu and Sheppard 1999) using GIS from all published bathymetric charts of atolls, banks and of the total archipelago. The quantity of substrate estimated is considerably greater than those given in some earlier estimates. While the seaward reefs of each atoll have the classical form of a reef flat at sea level, followed by a gentle slope to a 'drop-off' at about 10-15 m, followed by a steeper slope, there are interesting patterns in the depth distribution of substrate. For example, a simplified extract for depths less than 100 m depth (Fig. 3) reveals a greater proportion of substrate between 20-40 m than 40-70 m depth, and there is another increase of surface area between 70-90 m depth. In these atolls, peak coral diversity lies at 20 m depth, which is deeper than that recorded for most reef systems (Sheppard 1980). This was attributed to the high water clarity and appeared not to be influenced by the location of the drop-off.

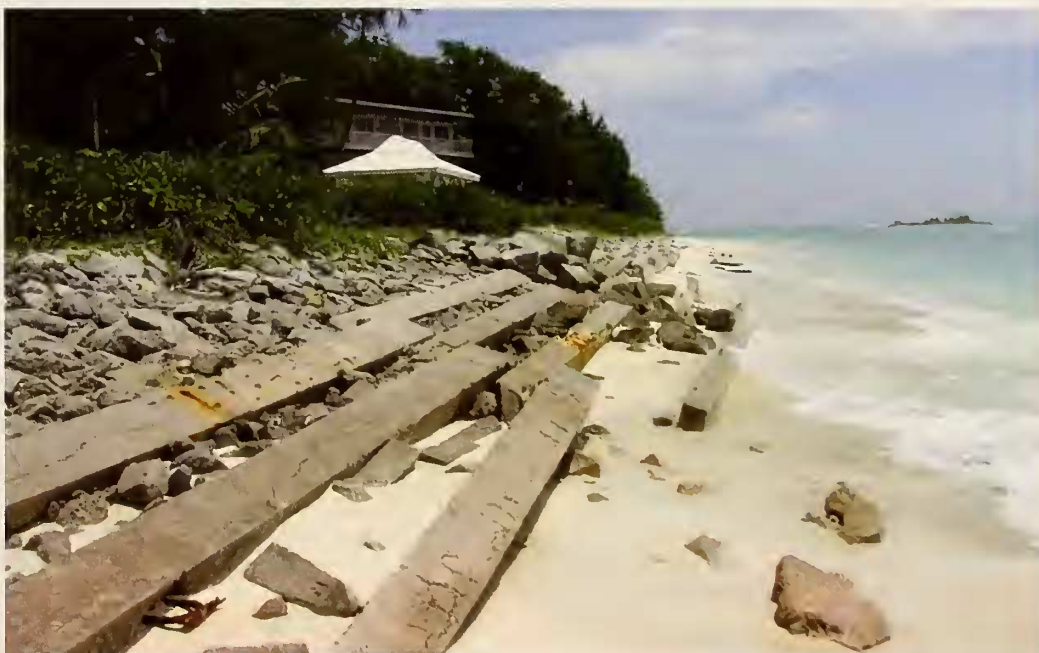
Figure 4. Northern tip of western Diego Garcia showing concrete armouring against erosion. The reef flat at this site is over 100 m wide. View looking North.

Erosion is now very evident in many places around many of the islands, and while this has continued progressively for many years it appears to have been accelerating over the last 8 years (scientific visits recommenced in 1996 after a gap of 17 years). Around much of the northern tip of Diego Garcia the erosion is striking; substantial shore defence has been put in place to stop further attrition (Fig. 4).

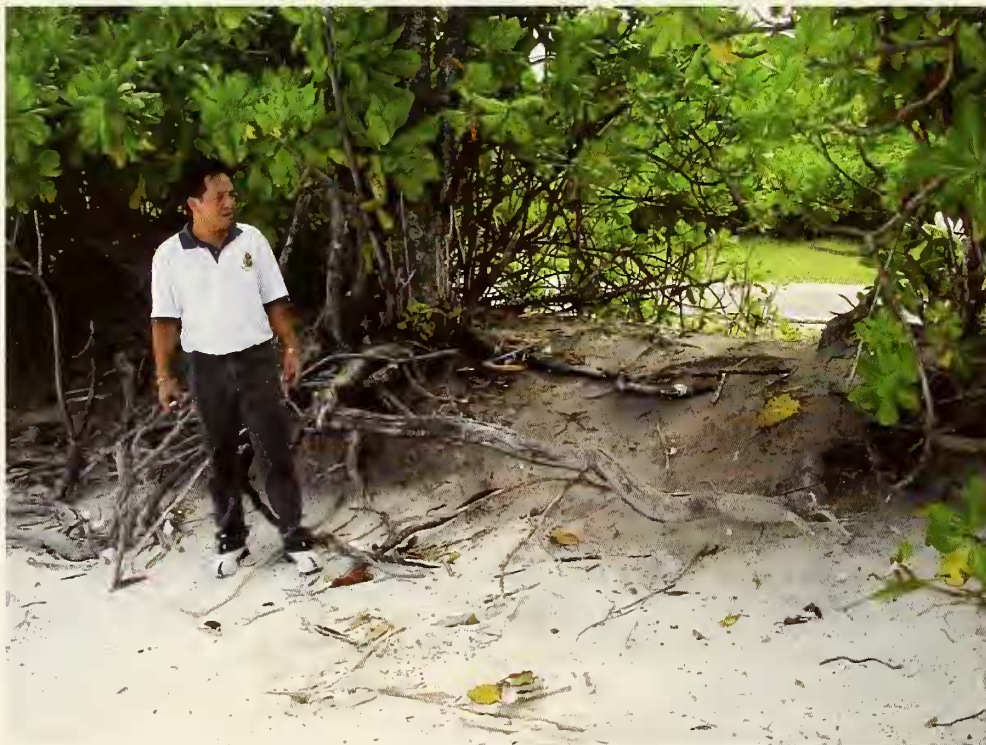
Figure 5. Erosion of the seaward side of the western arm of Diego Garcia. The observer is standing on the high tide level, the thin rim behind him is now all that stops inundation of the road at this point.

Further south, where a recreational club existed on the western side, there were steps leading down to the beach; now that shoreline is well eroded and the steps have disintegrated. By early 2006, most of the sand had disappeared from large stretches, exposing the underlying limestone. Further south still, the protective rim is now only about a metre wide in places and already some small plumes of beach sand are being pumped through onto the road at high tides (Fig.5).

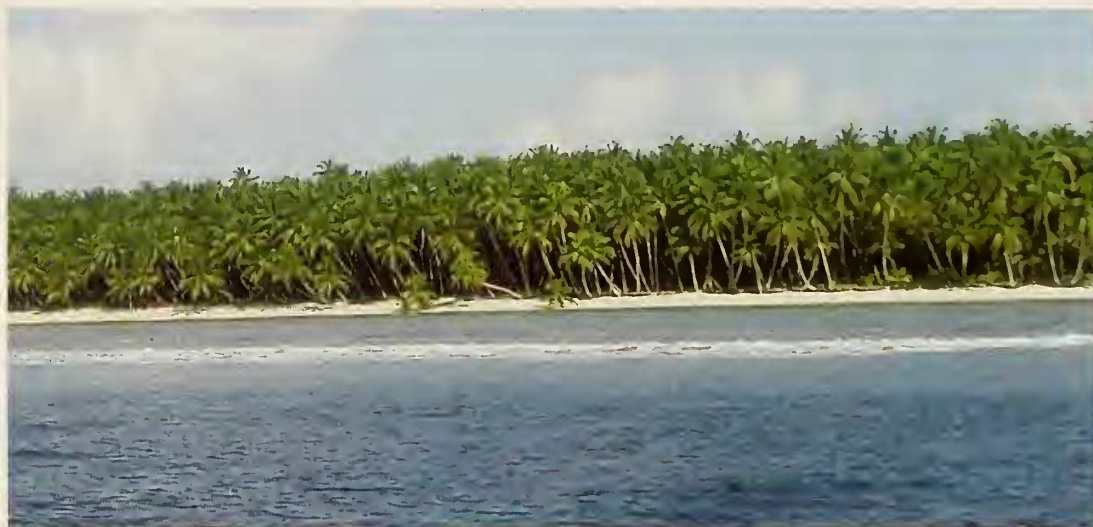
Figure 6. Section of the coast of NE Eagle Island where shoreline shrubs and 'undergrowth' have been removed by the tsunami. Breaking water marks the edge of the reef flat. This side of Eagle Island faces East, into the huge lagoon of the Great Chagos Bank.

Working northwards through the islands: on Eagle island on the Great Chagos Bank, on the north-eastern shore, there was a remarkable section of several hundred metres where the waves clearly punched 80 - 100 metres inland, stripping away the *Scaevola* bushes and young palms (Fig. 6) removing much of the previously gently sloping beach and leaving a 'step' of 1.5 m high (Fig. 7). When visited two months later, this area had no undergrowth (Fig. 8), but under the canopy of mature palms there were numerous newly sprouting coconuts. This shoreline damage, uniquely in this archipelago, continued around the northern tip and down the north-western facing side for some hundreds of metres too, illustrating the complicated refraction patterns of the waves. On North Brother, the little landing beach has been drastically changed and enlarged (Fig. 9) and the rim is now more narrow than previously. The entire eastern half of this island was clearly affected. The ground nesting Brown Booby colony which has been observed there since at least 1975 was almost certainly washed over, but the colony as a whole has survived. There were no young boobies or chicks in February

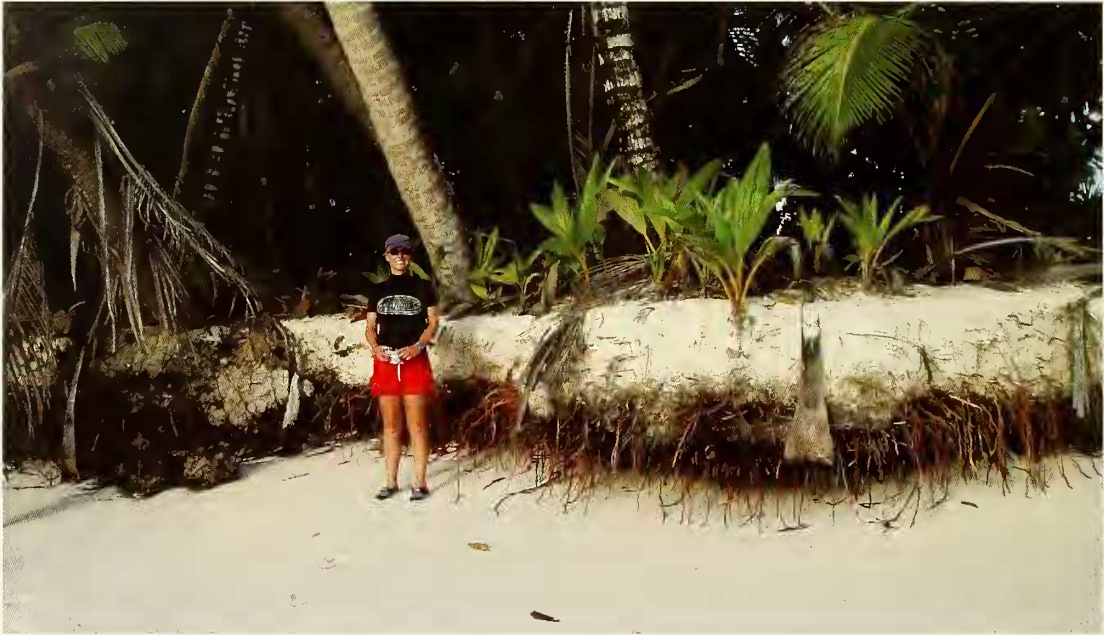
Figure 7. Observer providing scale to the 1.5 m step formed from eroded and undercut land, at the same site as Figure 6.

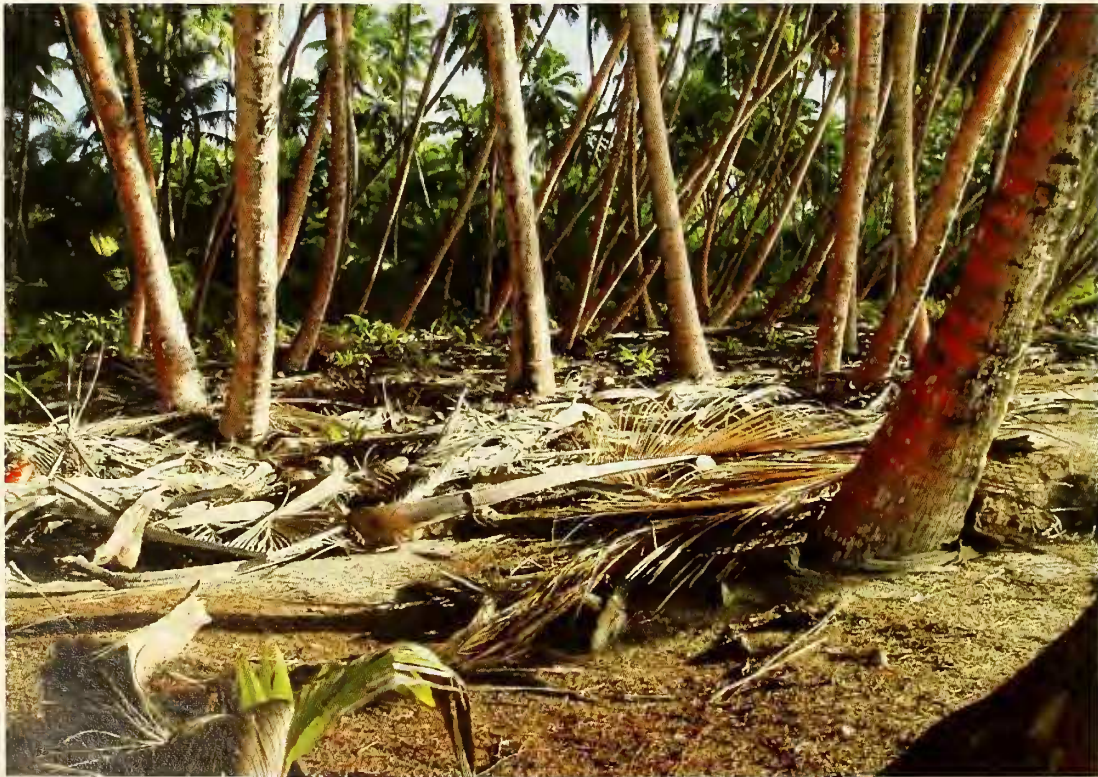
Figure 8. East Eagle Island where all undergrowth was removed, including young palms and *Scaevola*. The ground vegetation here (2 months later) is only of newly sprouted coconuts. This is the same site as Figure 6. The affected section of Diego Garcia has an identical appearance.

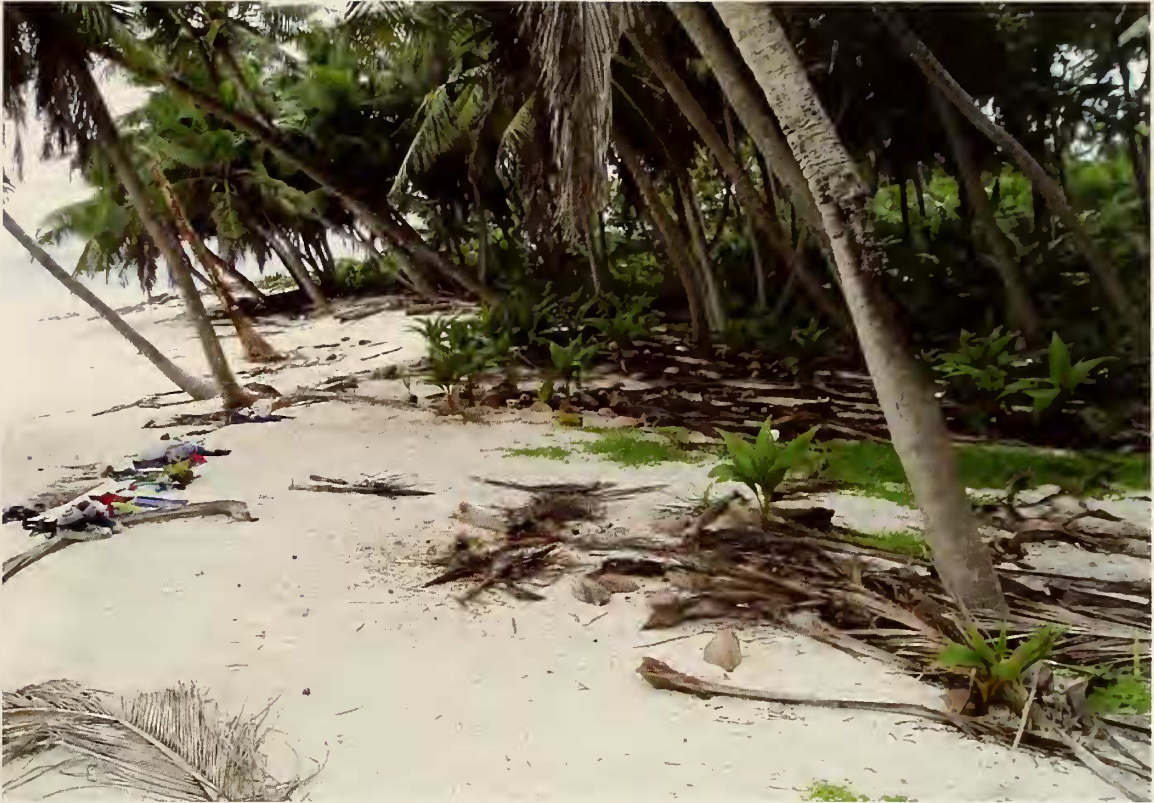
Figure 9. North Brother's thinning rim near the landing beach, facing approximately east. Shoreline shrubs are missing.

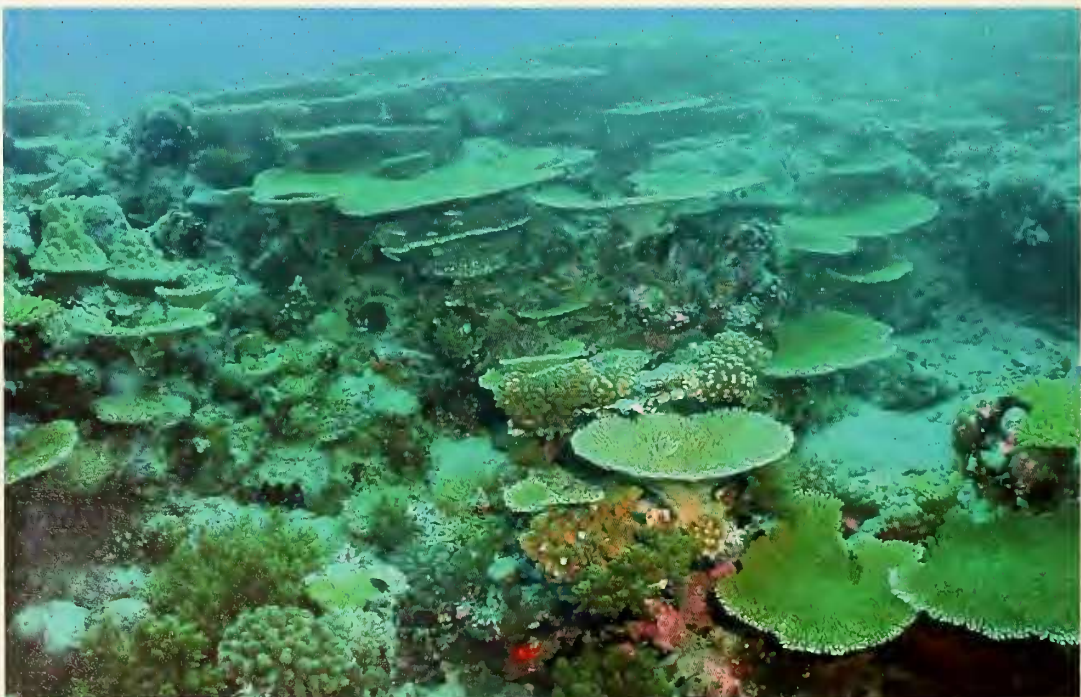
Figure 10. Underwater off Salomon atoll's Ile Anglais, located on the western side of the atoll, facing West, at the drop-off at 8 m depth. This seaward reef shows young and vigorous growth of table corals.

In the sublittoral, the reefs were inspected by snorkelling at all the above sites, as well as on east and west sides of Diego Garcia and Salomon atolls, and on the east side of Eagle Island (Great Chagos Bank), West Peros Banhos and in North-East Egmont. The results must be set against the observation, noted above, that coral mortality was very heavy following the 1998 warming, when over 90% of corals were killed to at least 10 and sometimes 30 m deep (Sheppard, 1999). Broadly, while western facing sites which had shown some recovery in 2002 showed much more recovery in 2005 (Fig. 10), those eastern facing sites which had shown almost no recovery in 2002 still showed little recovery.

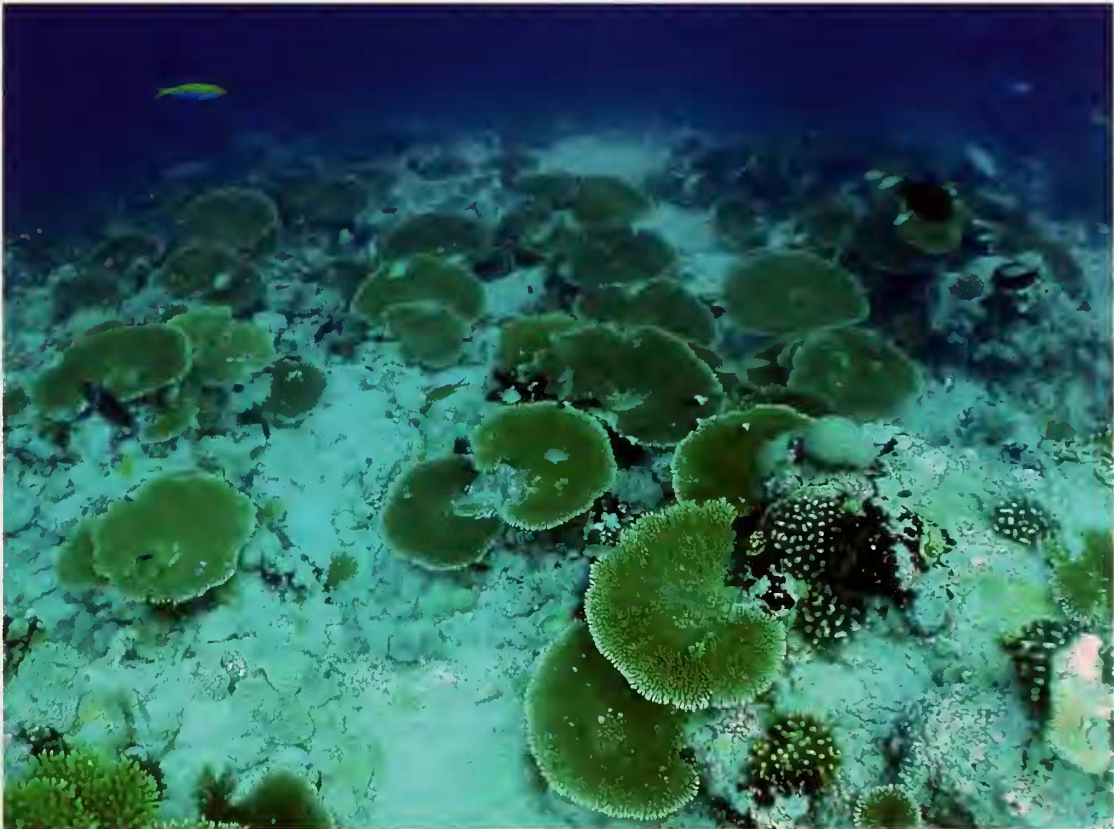
Figure 11. North-eastern end of Nelson Island, Great Chagos Bank, showing young and vigorous growth of table corals. The drop-off here is 6 m depth.

This pattern was not universal, however: the side of Nelson Island facing Sumatra was seen to be recovering well with good cover of tabular *Acropora* corals (Fig. 11), and similarly, the eastern side of Eagle island off the section where vegetation was stripped away, coral recovery was modest, but included many branching species which remained undamaged (Fig. 12). In eastern Diego Garcia, considerable coral rubble was seen in some eastern seaward locations, but not in others. In all sites, the limited recovery of coral cover that had occurred included healthy colonies of relatively fragile species.

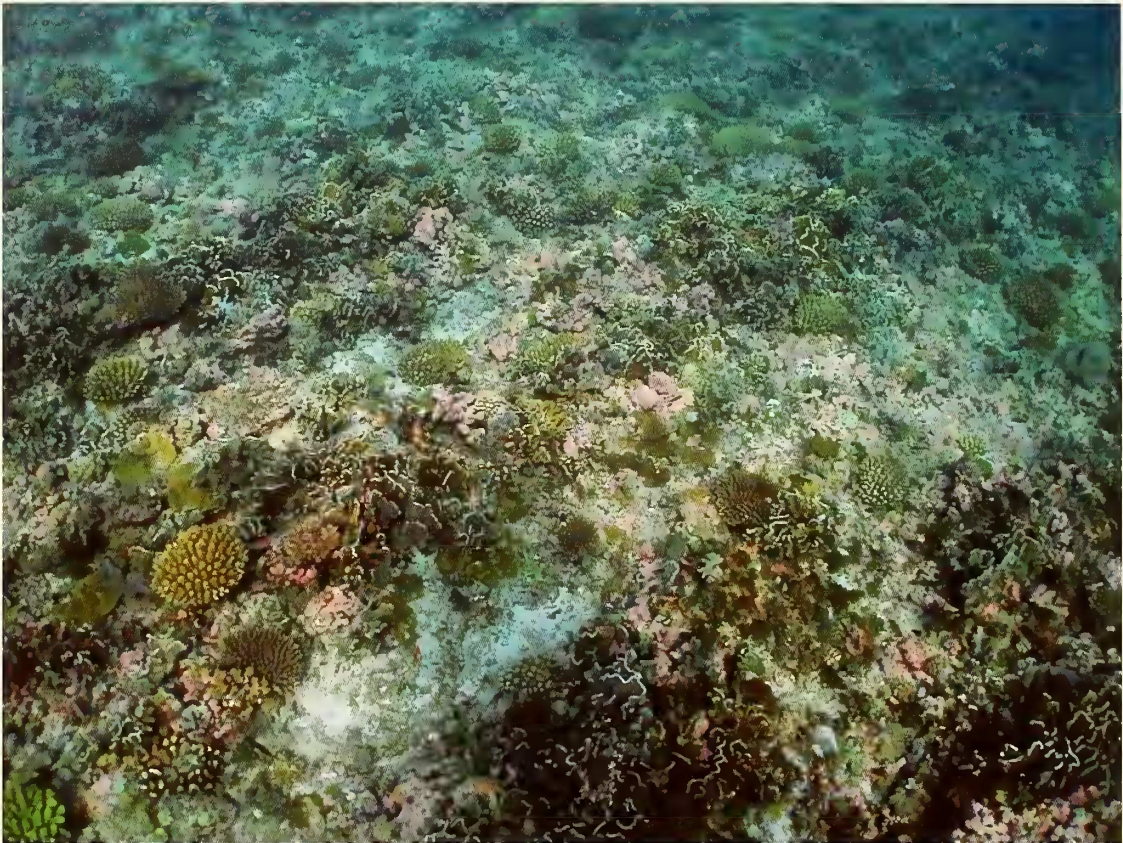
Figure 12. Eagle Island, eastern or lagoon-facing slope, 7 m depth, offshore from the most heavily affected shoreline. This site is located beneath where Figure 6 was taken. Much of this substrate is covered with *Heliopora*.
